# Manhole Inspection Summary

Manhole # S3100\_018MH

Insp Date: **4/25/07 9:58 AM**

**Location** Address: **330 24TH ST**

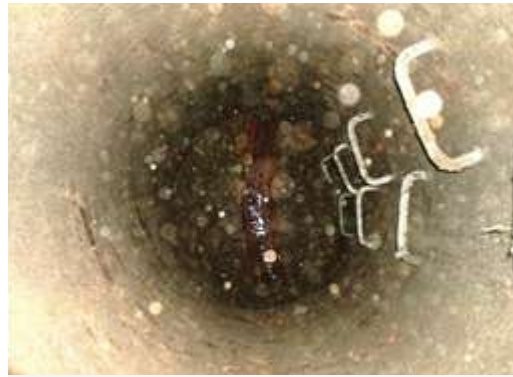
Top View

Corroded steps. Bench debris.

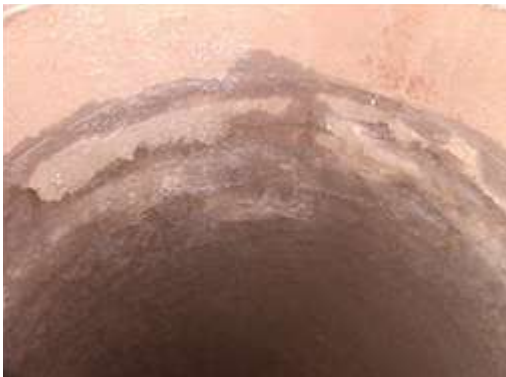
Defect

Frame leaks. Adjustment deterioration and infiltration. Corbel infiltration - other side.

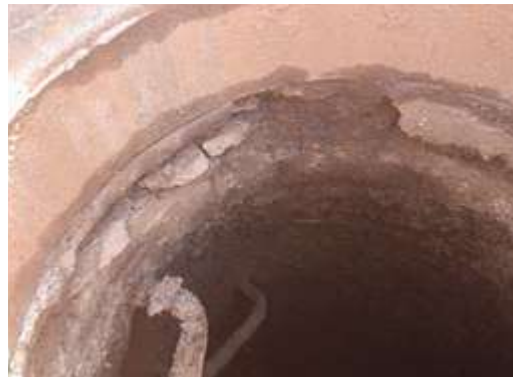
Defect

Frame leaks. Adjustment deterioration and infiltration. Corbel infiltration.

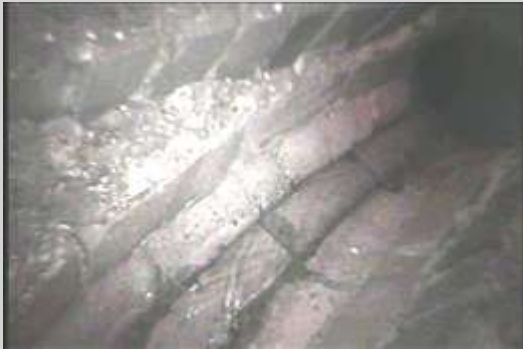
### 8 in. Circular Gravity Sewer Pipe Out @ 12 O'Clock

Infiltration: **None** Pipe Seal Cond: **Unknown**

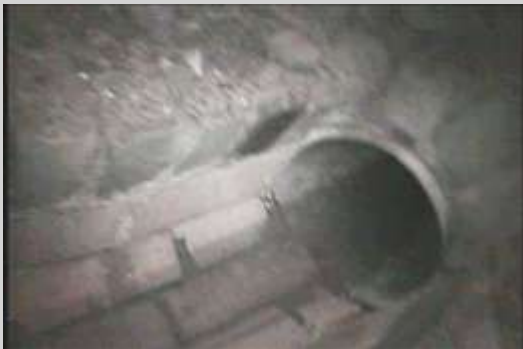
### 8 in. Circular Gravity Sewer Pipe In @ 5 O'Clock

Infiltration: **Evidence** Pipe Seal Cond: **Unknown**
